PRELIMINARY ASSESSMENT  
OF THE  
ROGERS ELECTRIC COMPANY  
(MD-445)

MARCH 1993

Prepared by: Maryland Department of the Environment  
Waste Management Administration  
Environmental Response and Restoration Program  
2500 Broening Highway  
Baltimore, Maryland 21224

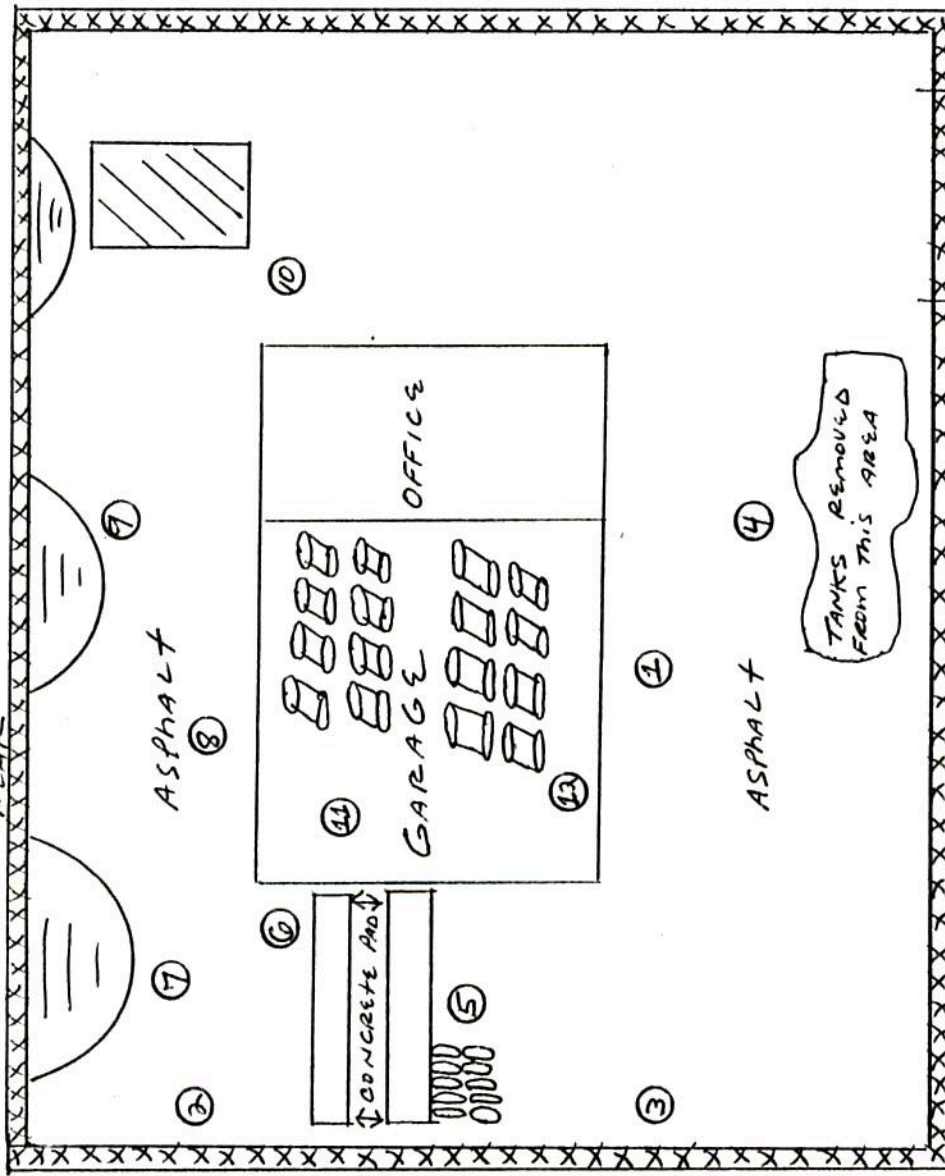
Site SKETCH  
(Not to Scale)

Storage Area  
Construction

TANKS REMOVED  
FROM THIS AREA

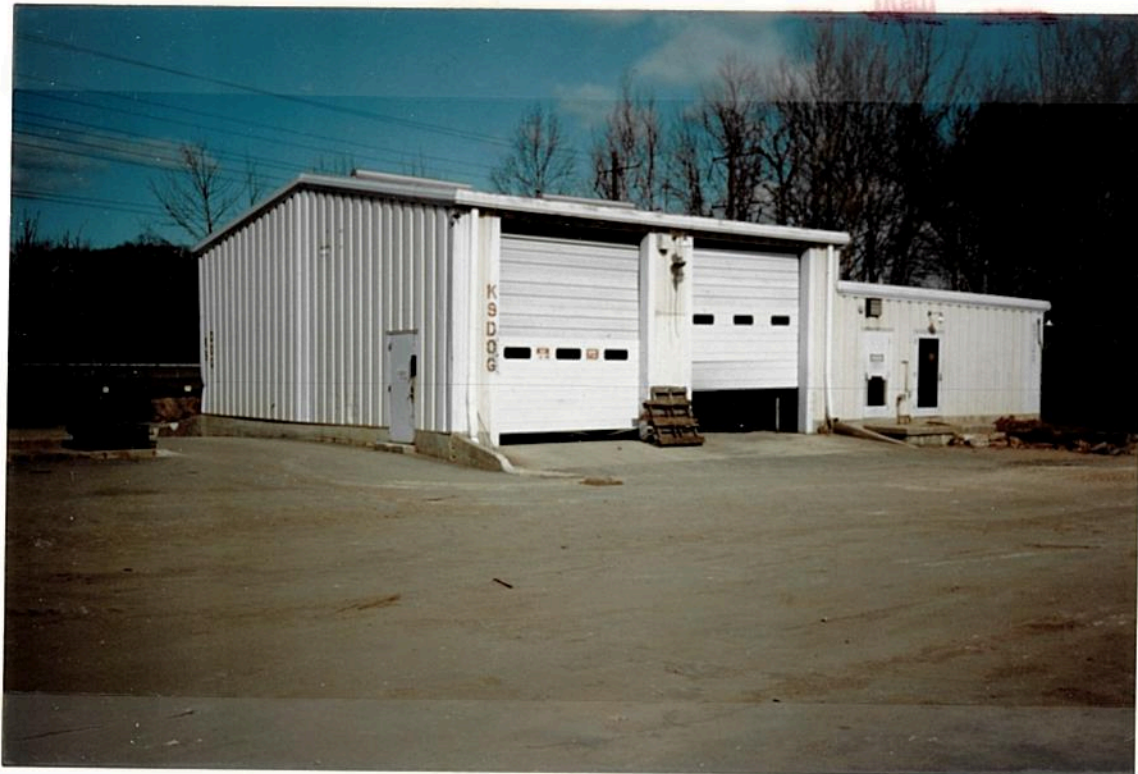
1. Office Building and Storage Area (Drums stored inside storage area). Photo facing northeast.

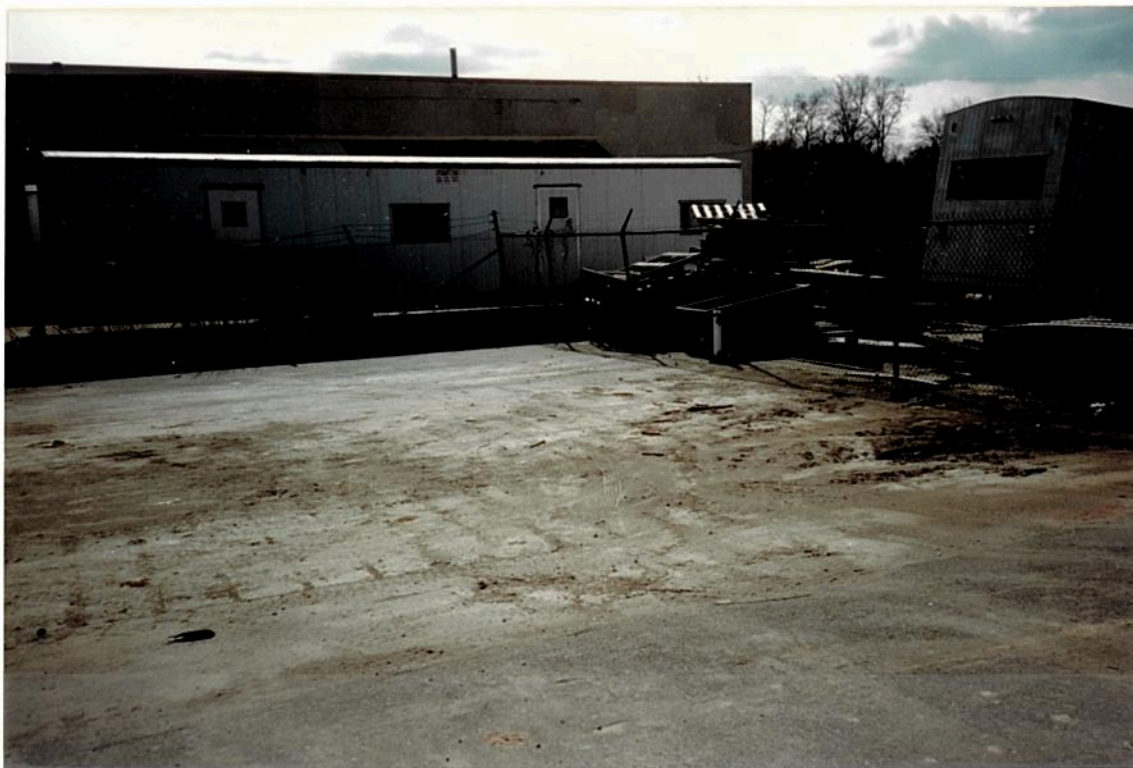
2. Property boundary of site, northwest corner. Property outside of fence belonging to Blake Construction.

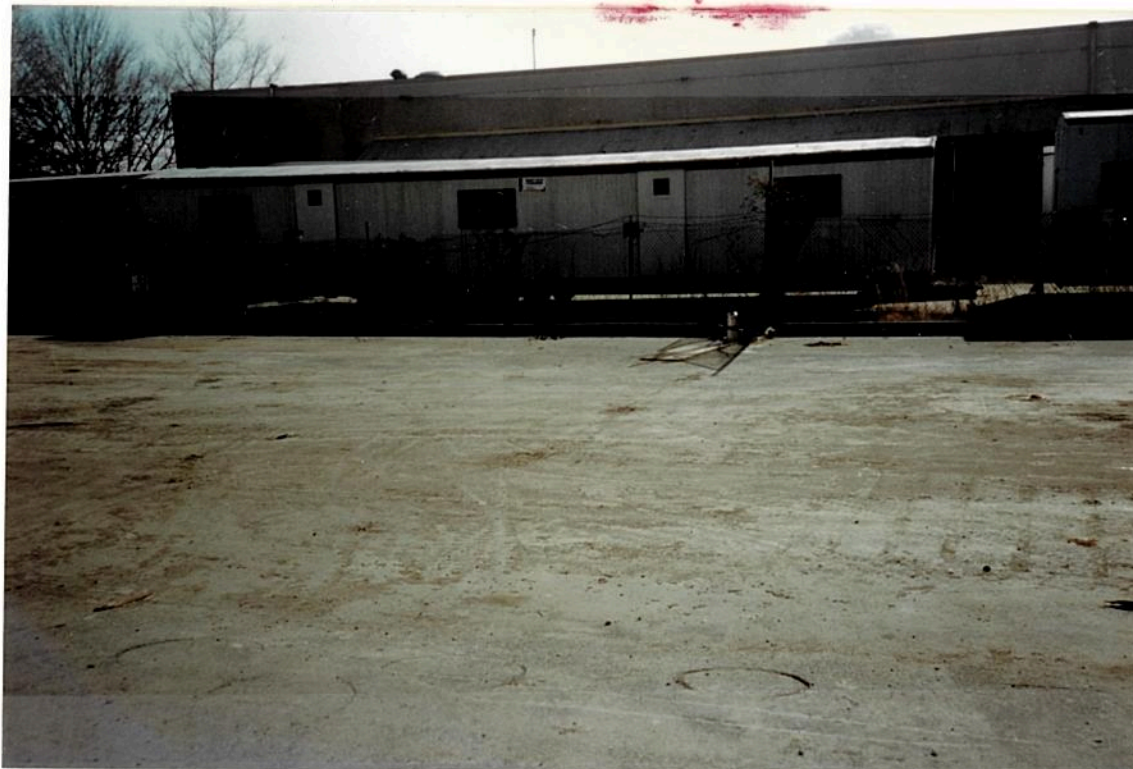
3. Property boundary of site, westward side. Asphalt pavement covered with dirt in foreground. Note previous drum area in foreground by "ring" indentation.

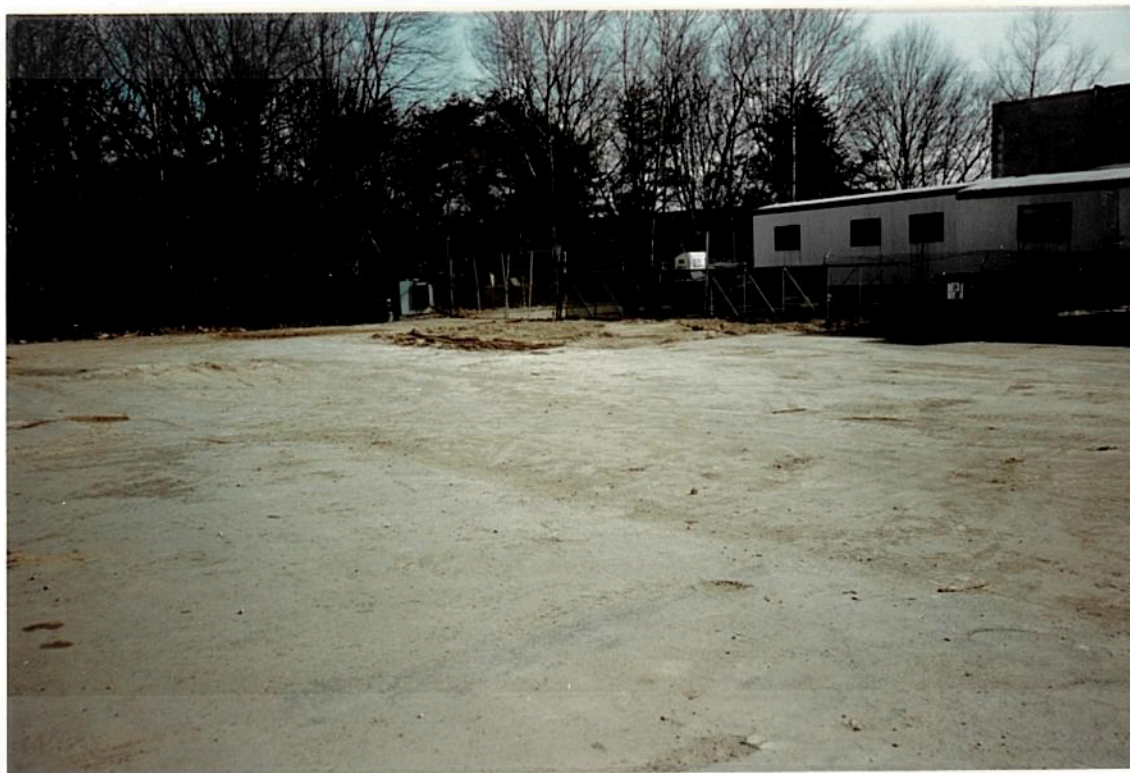
4. Area where underground storage tanks (2) were removed in background. Also, property (gate) entrance. Photo facing southeast.

In addition, two underground storage tanks were removed in October 1992 which formerly contained petroleum products. One UST was reported to be of 10,000 gallon capacity and the other UST had a holding capacity of 12,000 gallons.

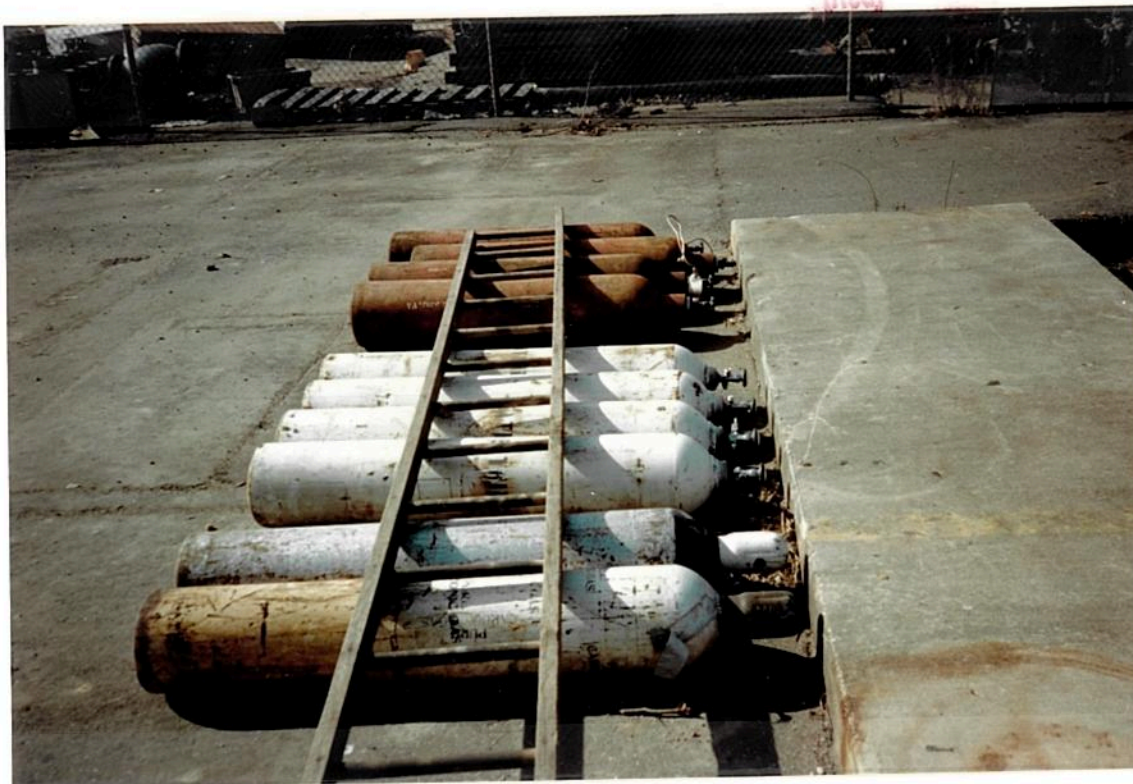
5. Photograph of ten empty cylinders located on west side of building. Concrete pad located to the right. Photo facing west.

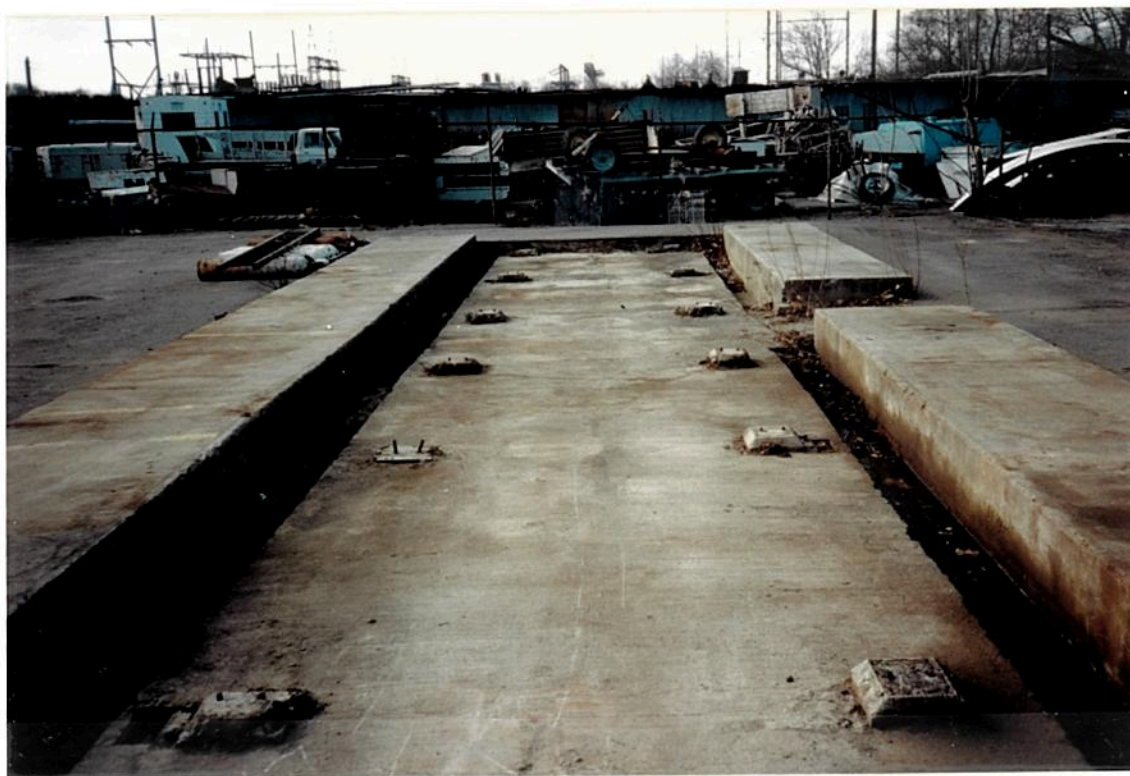
6. Concrete pad area where PCB contaminated transformers were previously stored. Photo facing west.

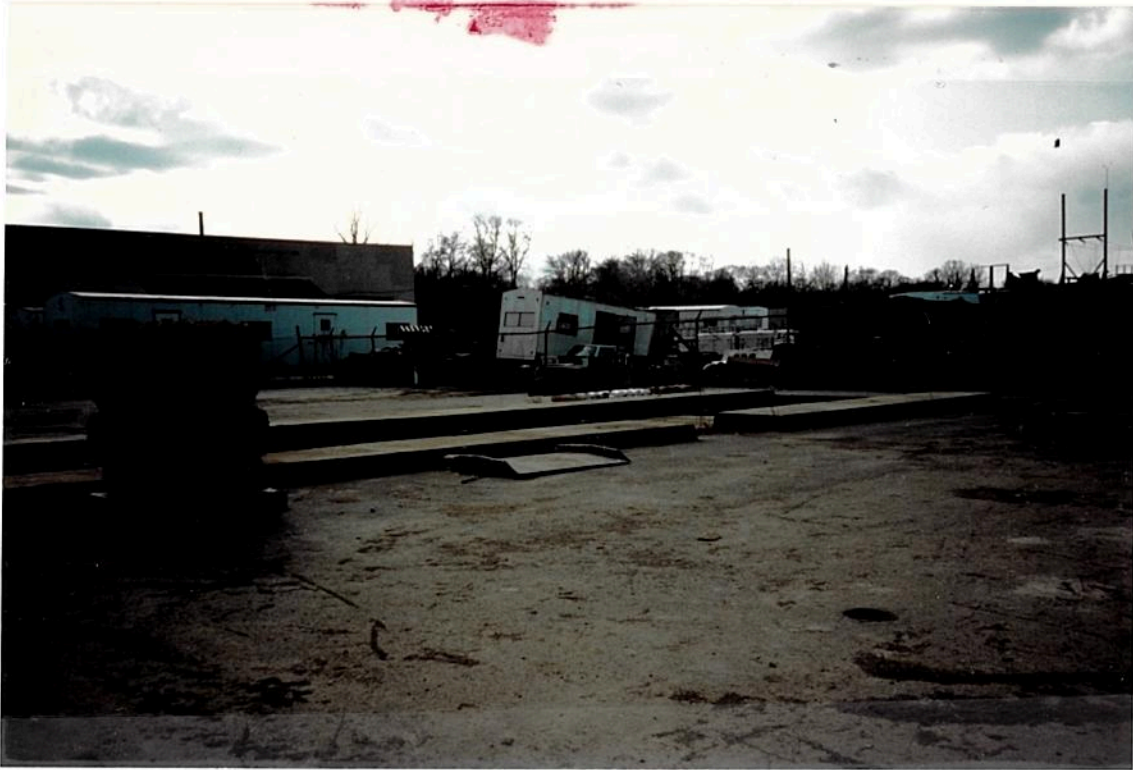
7. Concrete pad area and property boundary. Photo facing southwest.

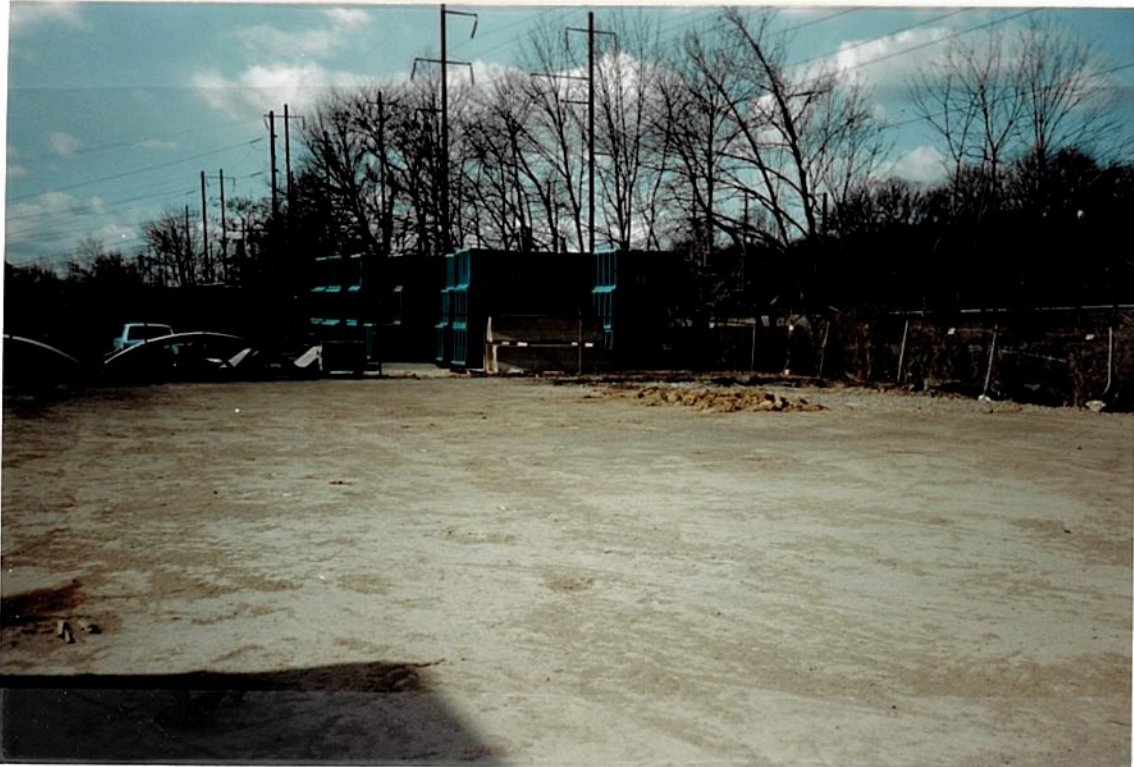
8. Excavated soil area in background. Property boundary (fence) on the northwest side of site.

After the excavation and removal of the two underground storage tanks, soil borings were taken from four different locations at the facility. The borings revealed traces of surficial oil contamination only. That soil was removed from the site and the remaining soils were placed back into the excavated areas.

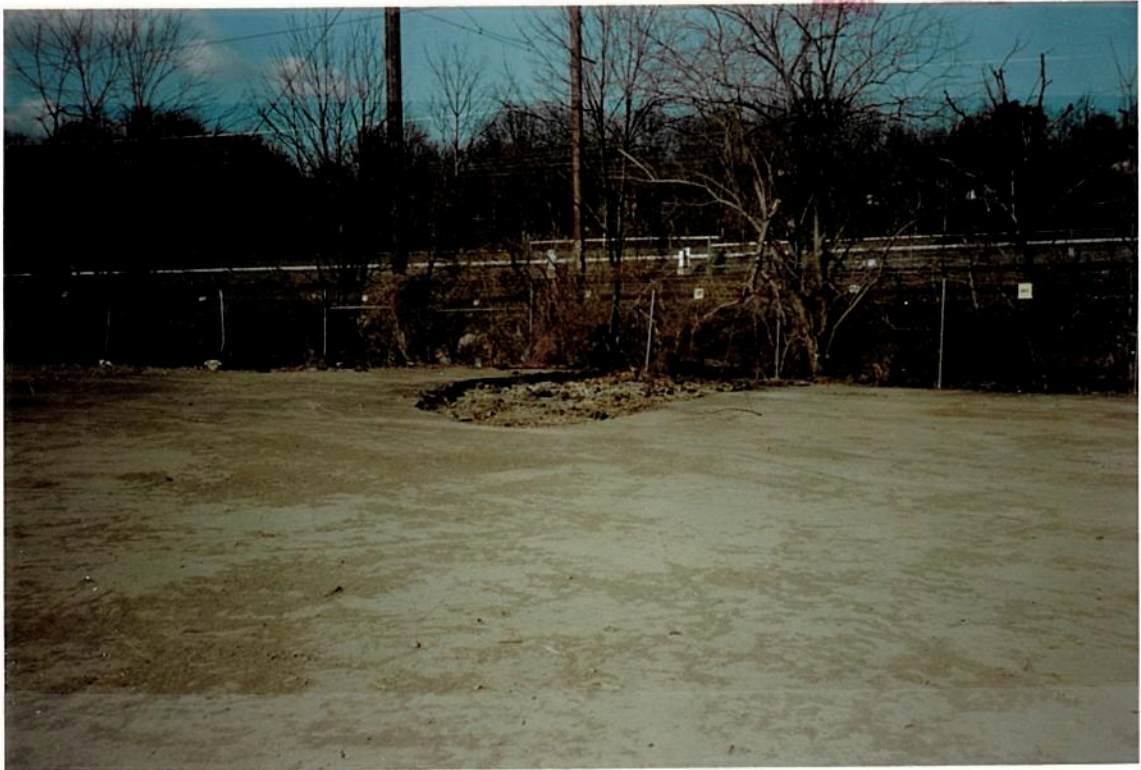
9. Photograph facing north. Excavated soil area in background. Beaverdam Creek (PPE) located just beyond fence line, before railroad tracks.

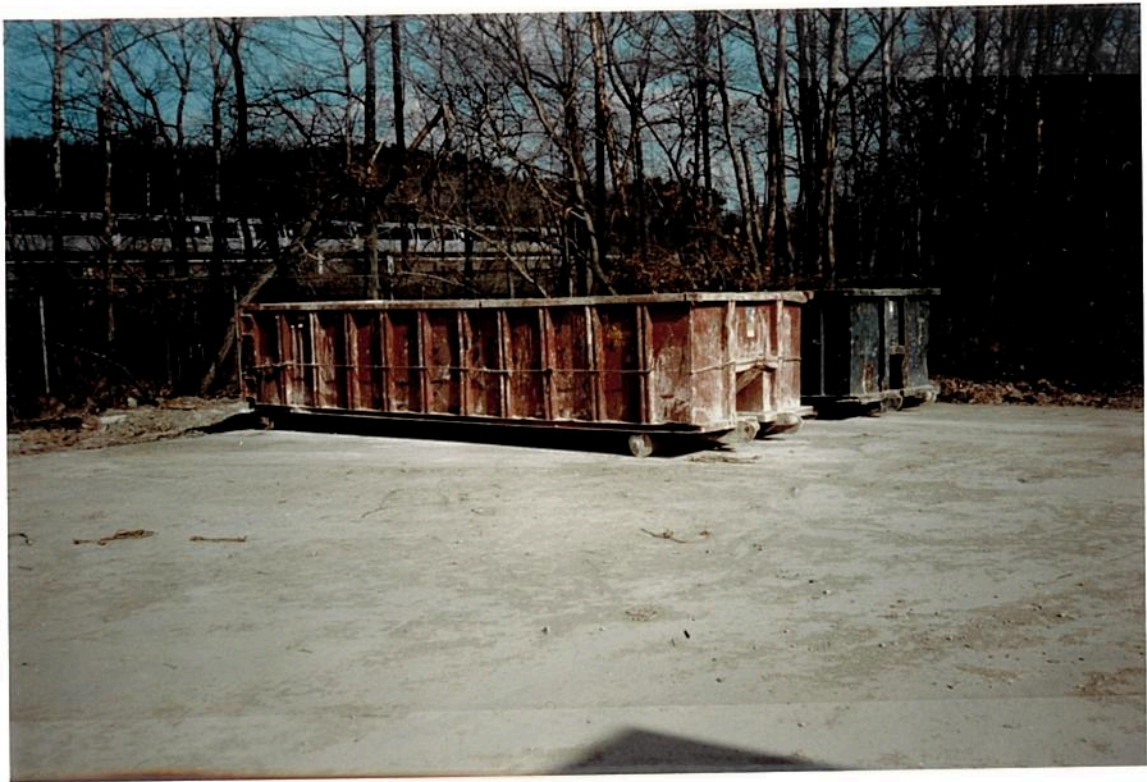
10. Empty roll-away waste containers. Photo facing northeast.

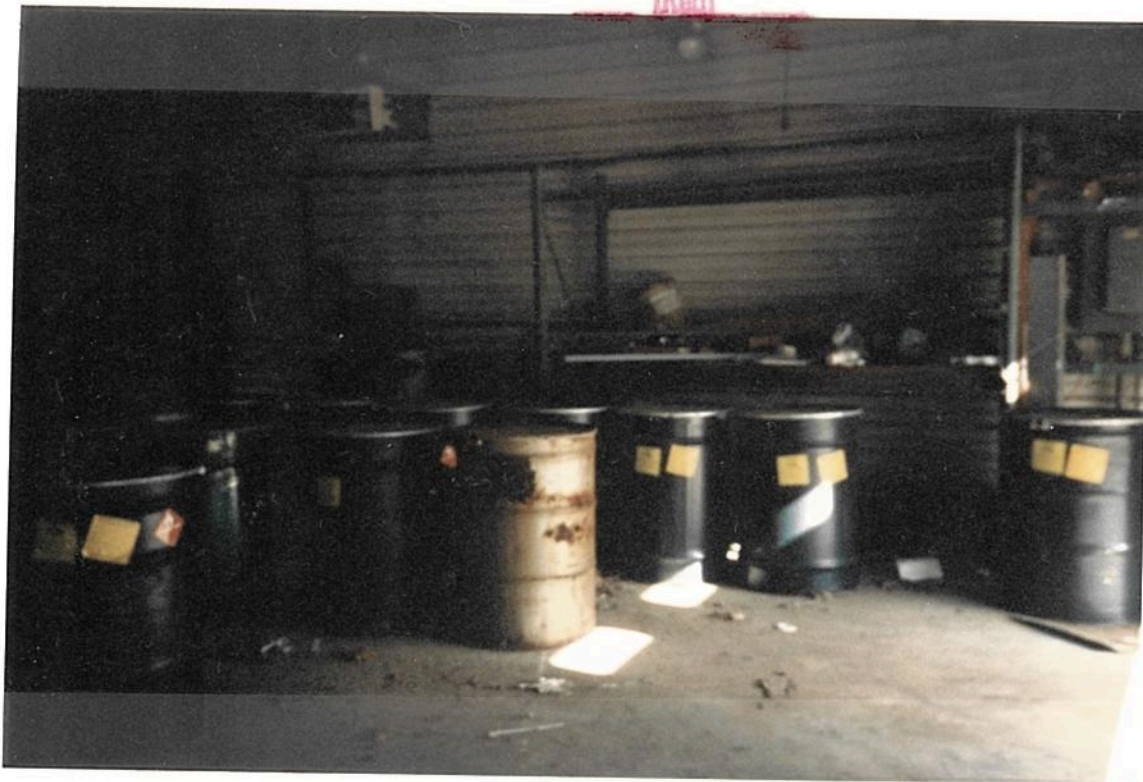
11. PCB contaminated liquids stored inside 55 gallon drums. Photo taken inside of storage area inside building. Note rust (corrosive) on white drum in middle of photograph.

At the time of the site reconnaissance, forty 55 gallon drums filled with PCB related materials were located in the staging area inside the building. It is unknown to this writer whether or not the drums had exceeded the 90 day storage requirement. In addition to the drums, one large roll-off container loaded with PCB/RCRA wastes was ready for off site disposal. The container was covered with plastic sheeting.

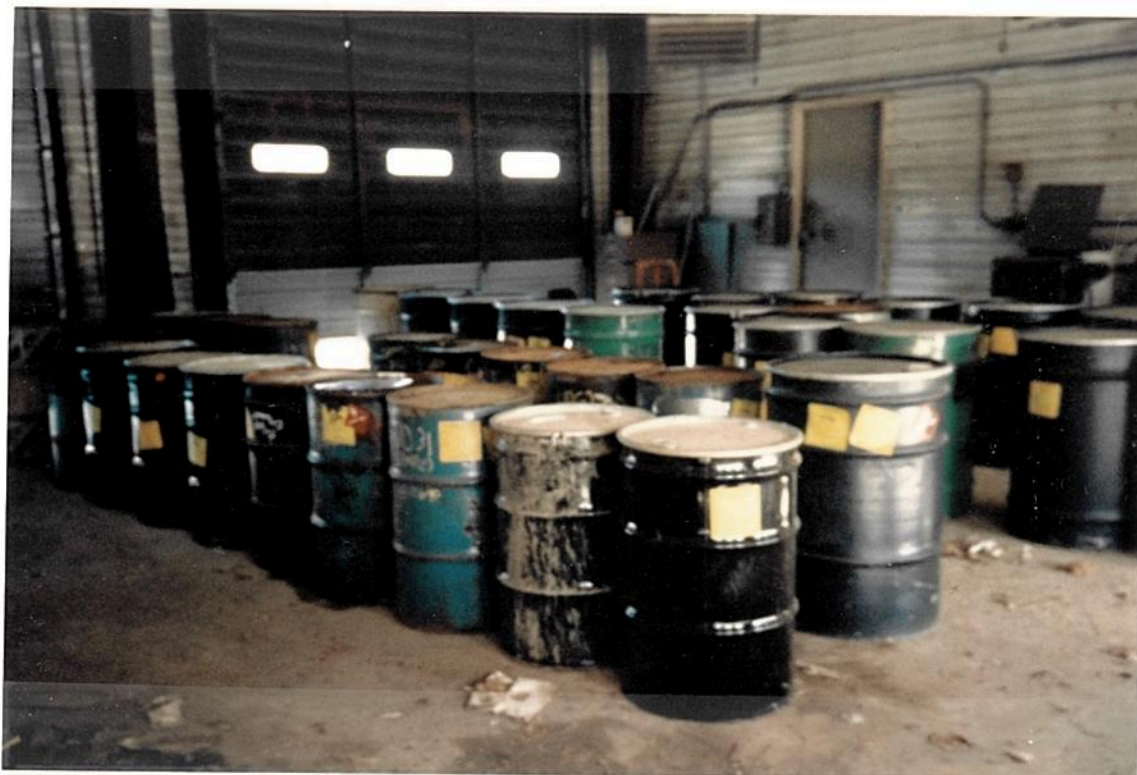
12. PCB contaminated liquids stored in 55 gallon drums inside building. Drums labeled as hazardous waste product.
